Test Report

*Commercial
fire test*

Subject: ITS Letter Report No. J20022860-231

This was a pilot scale (48" high x 72" wide) fire endurance test to investigate the possibility for 120 minute fire rating of a wall. This test was conducted for compliance with ASTM E119-95a "*Standard Test Methods of Fire Tests of Building Construction and Materials*", CAN/ULC-S101, NFPA 251 (1999), UBC Standard 7-1 (1997) and UL 263 (1997).

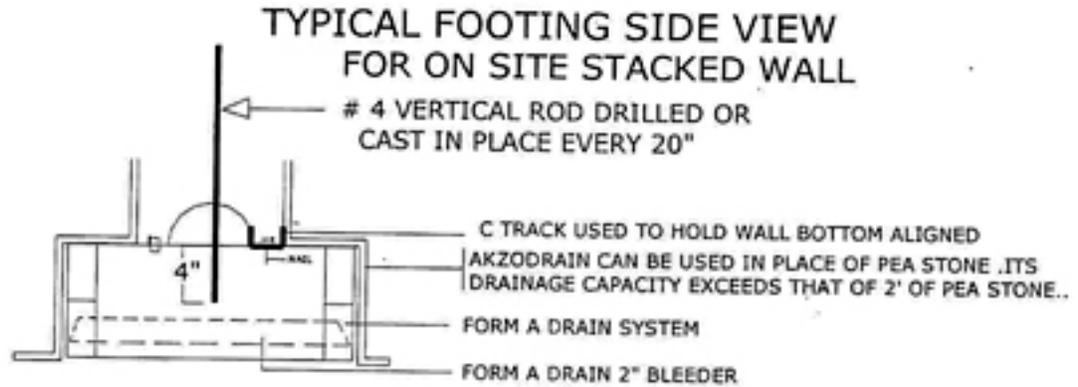
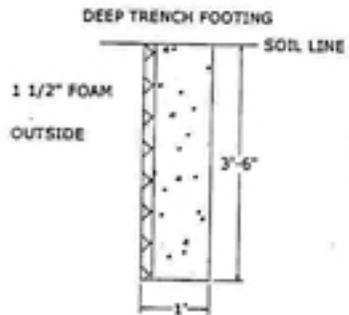
FIGURE A: FOOTING WITH C-TRACK

WALL: A 48" high x 72" wide wall consisting of 10" wide polystyrene honeycomb blocks. The bottom layer of blocks is placed on a 1" high x 2" wide steel "C track" to keep the blocks straight (see figure A). The rest of the blocks were then glued to each other in regular stagger pattern. A piece of #4 steel rebar (3/8" thick) was placed into the bottom most horizontal column and into every other vertical column (20" on center). The wall was filled with concrete and covered with 2 layers of 5/8" Type X gypsum on both sides. Secured with 3-1/2" drywall screws spaced 8" on center into the 3/4" x 3/4" steel vertical track that is spaced 10" on center and anchored into the concrete. All joints were taped and treated with joint compound and all screw heads were treated with joint compound as well.

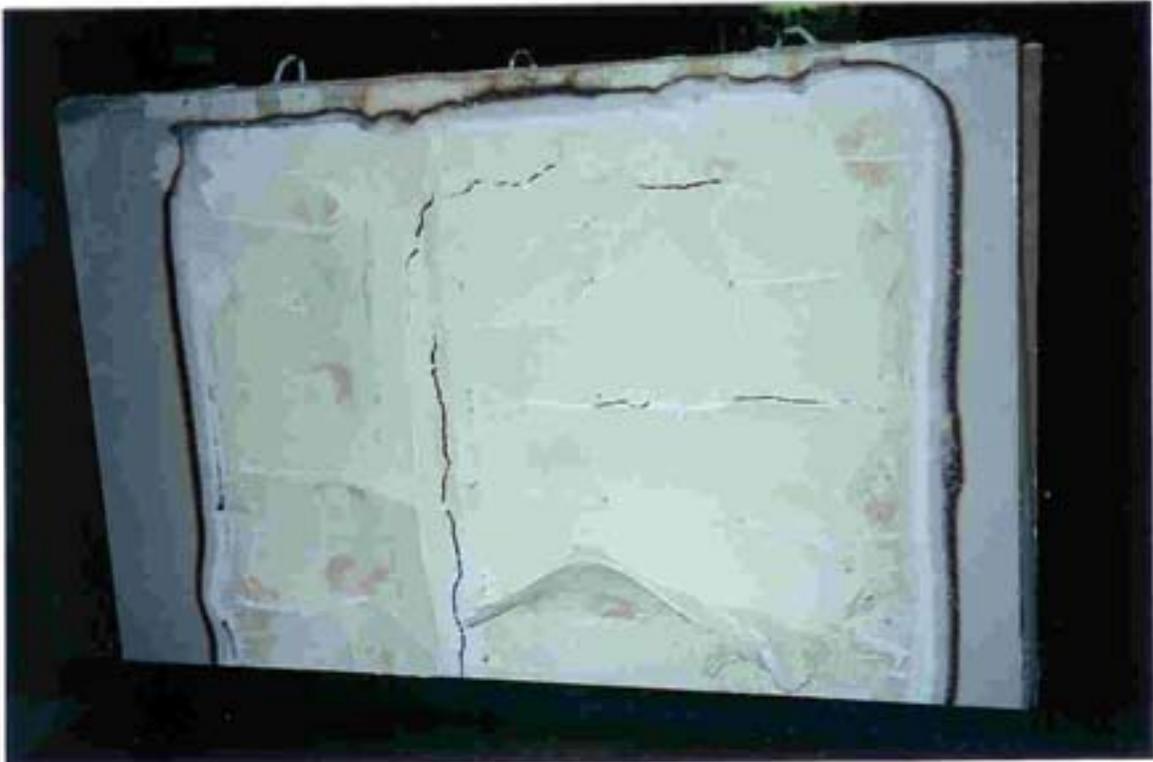
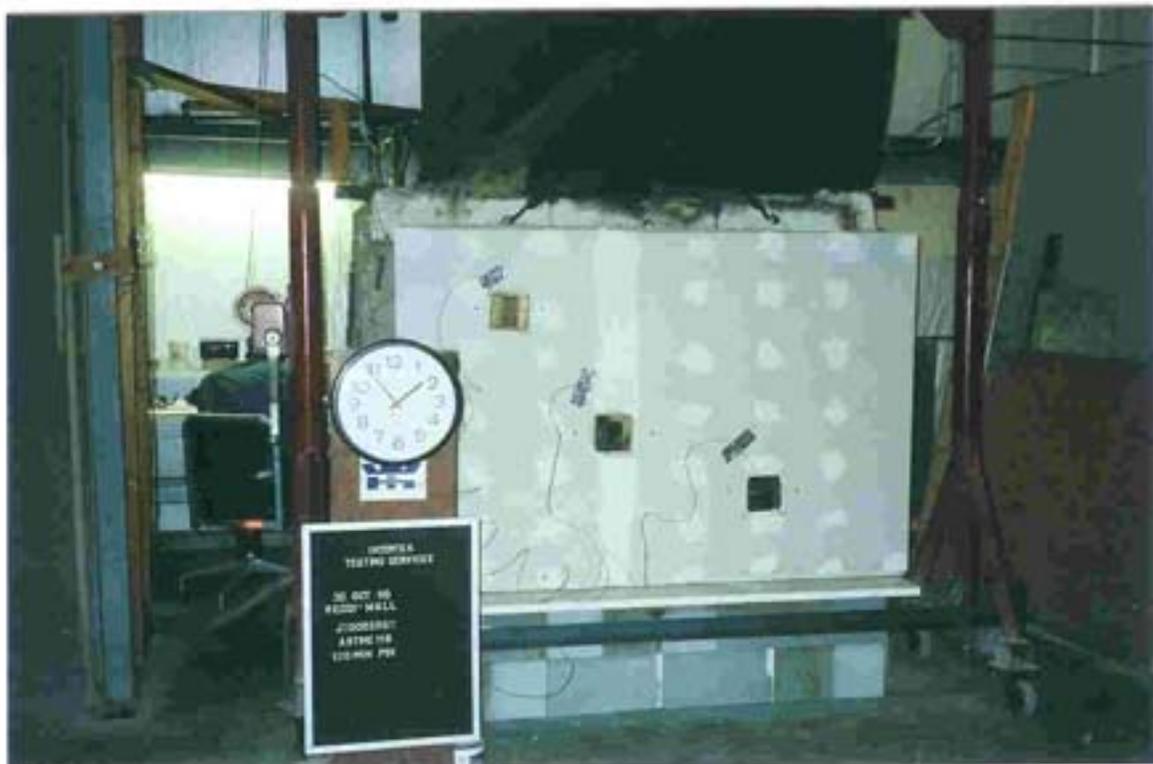
FIRE ENDURANCE

<u>TIME</u> (min:sec)	<u>EXPOSED FACE</u>
00:00	Furnace ignited.
03:19	Gypsum panel paper ignited.
13:48	Vertical crack forming in gypsum panel approximately 4" away from tapped vertical joint.

20:00	Vertical crack entire height of sample 1/8" wide. Small horizontal cracks at mid height.
30:00	Vertical crack 1/4" wide. Horizontal crack full width of sample 1/8" wide. Horizontal crack approximately 5" from top forming starting to spread towards edges 1/8" wide.

50:00	All cracks increasing in width. Vertical crack 1/2" wide.
60:00	Largest vertical crack 3/4" wide.
75:31	Flaming coming out of cracks in gypsum, second layer of gypsum cracking.

90:00	First panels cracks now 1" wide. Second panel cracks spreading.
105:00	First layer of gypsum falls off; cracks in second layer now 1/4" wide. Flaming from cracks increases.

110:00	Top quarter of first layer gypsum panel fell of into the furnace.
120:00	Test stopped.

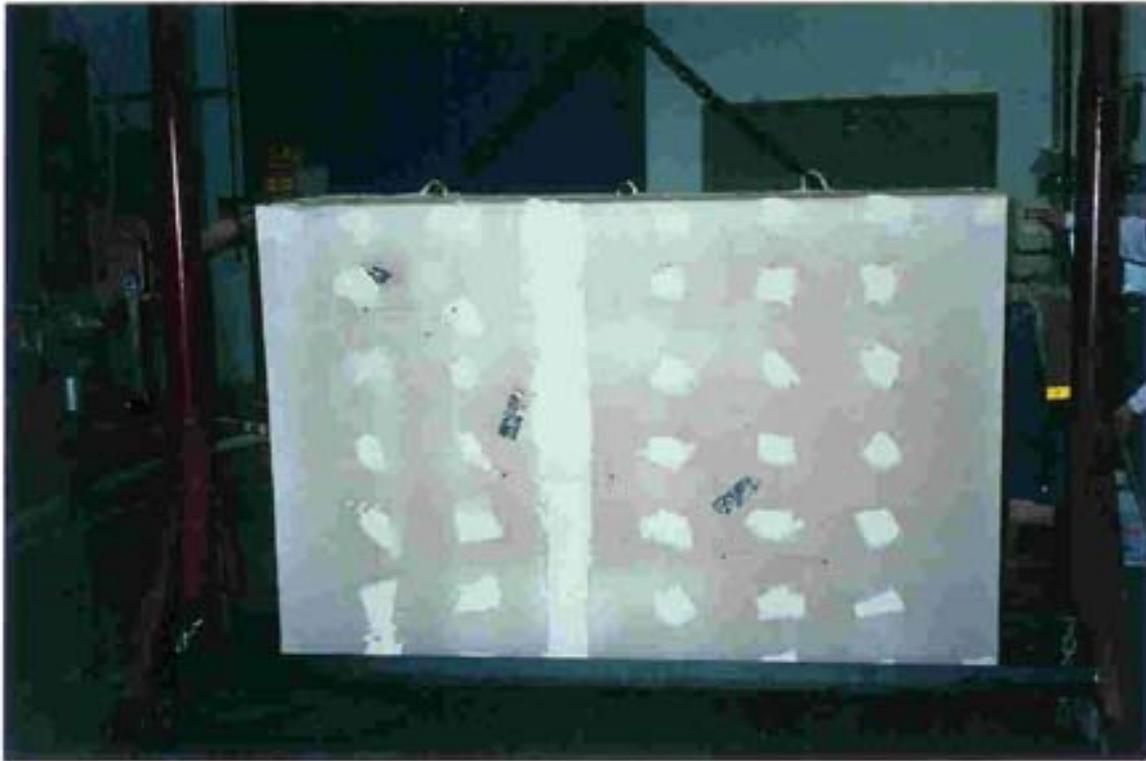
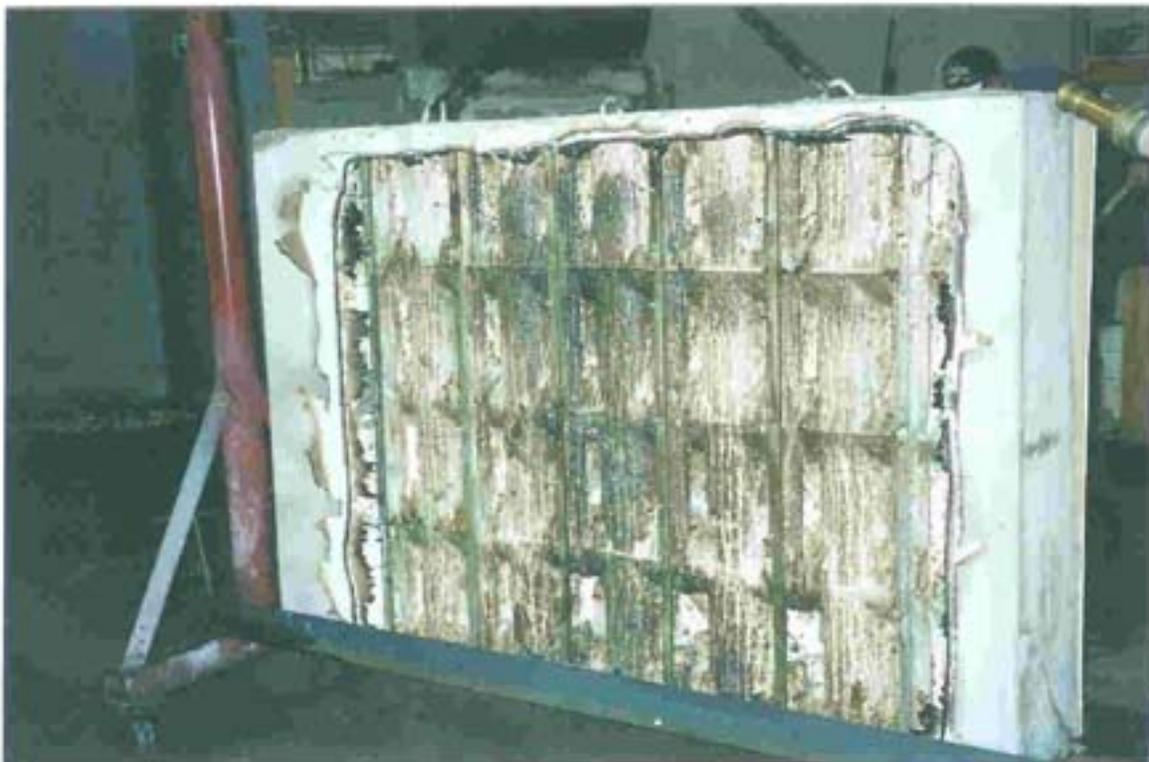
AFTER HOSE STREAM TEST

A Hose Stream Test was conducted for 36 seconds at 30 psi. Test assembly passed hose stream test with no through opening and allowable movement limits.
